DATA SHEET 5 – ACCEPTABLE APPEARANCE FROM TIMBER FLOORS

Timber Queensland Ltd and the Timber Flooring and Finishing Association of Queensland have jointly prepared this publication as part of a flooring research project for the Forest and Wood Products Research and Development Corporation.

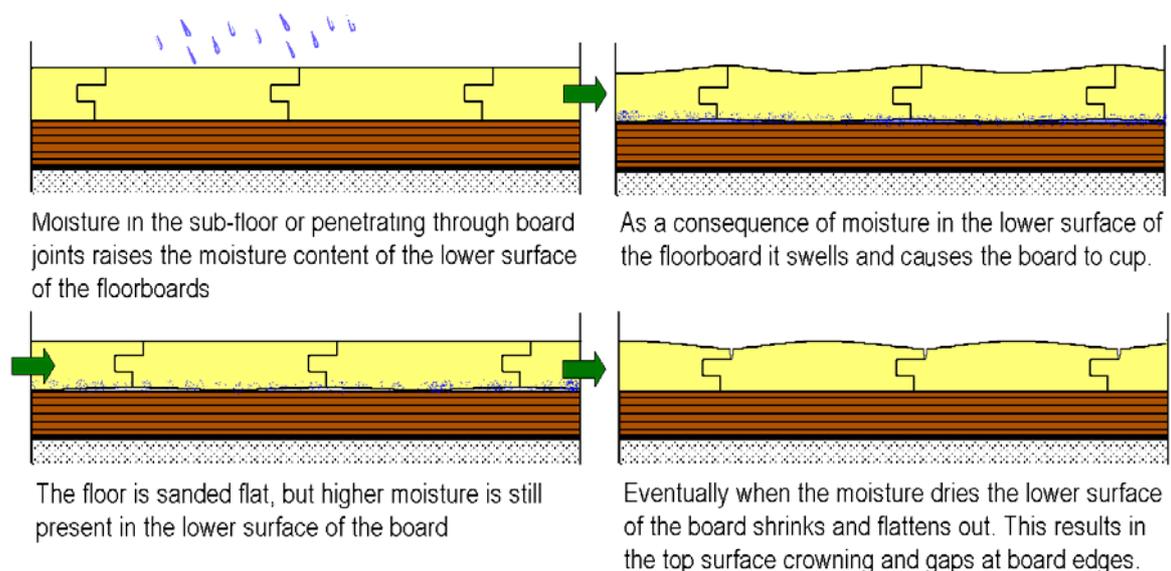
Figure 5a – The process of crowning

Note: Floors exposed to heat sources after occupancy (e.g. no curtains, fireplaces, vents from appliances, houses closed up for extended periods) may cause boards to cup. Cupping and shrinkage from such sources may be the owner's responsibility.)
